Quinquennial Inspection Report

St Gregory's Church, Church Street, Dawlish,
Devon EX7 9QT

Written by:	Mark Ledgard
Checked by:	Tim Colling
Issue date:	28 th March 2022
File reference:	491081

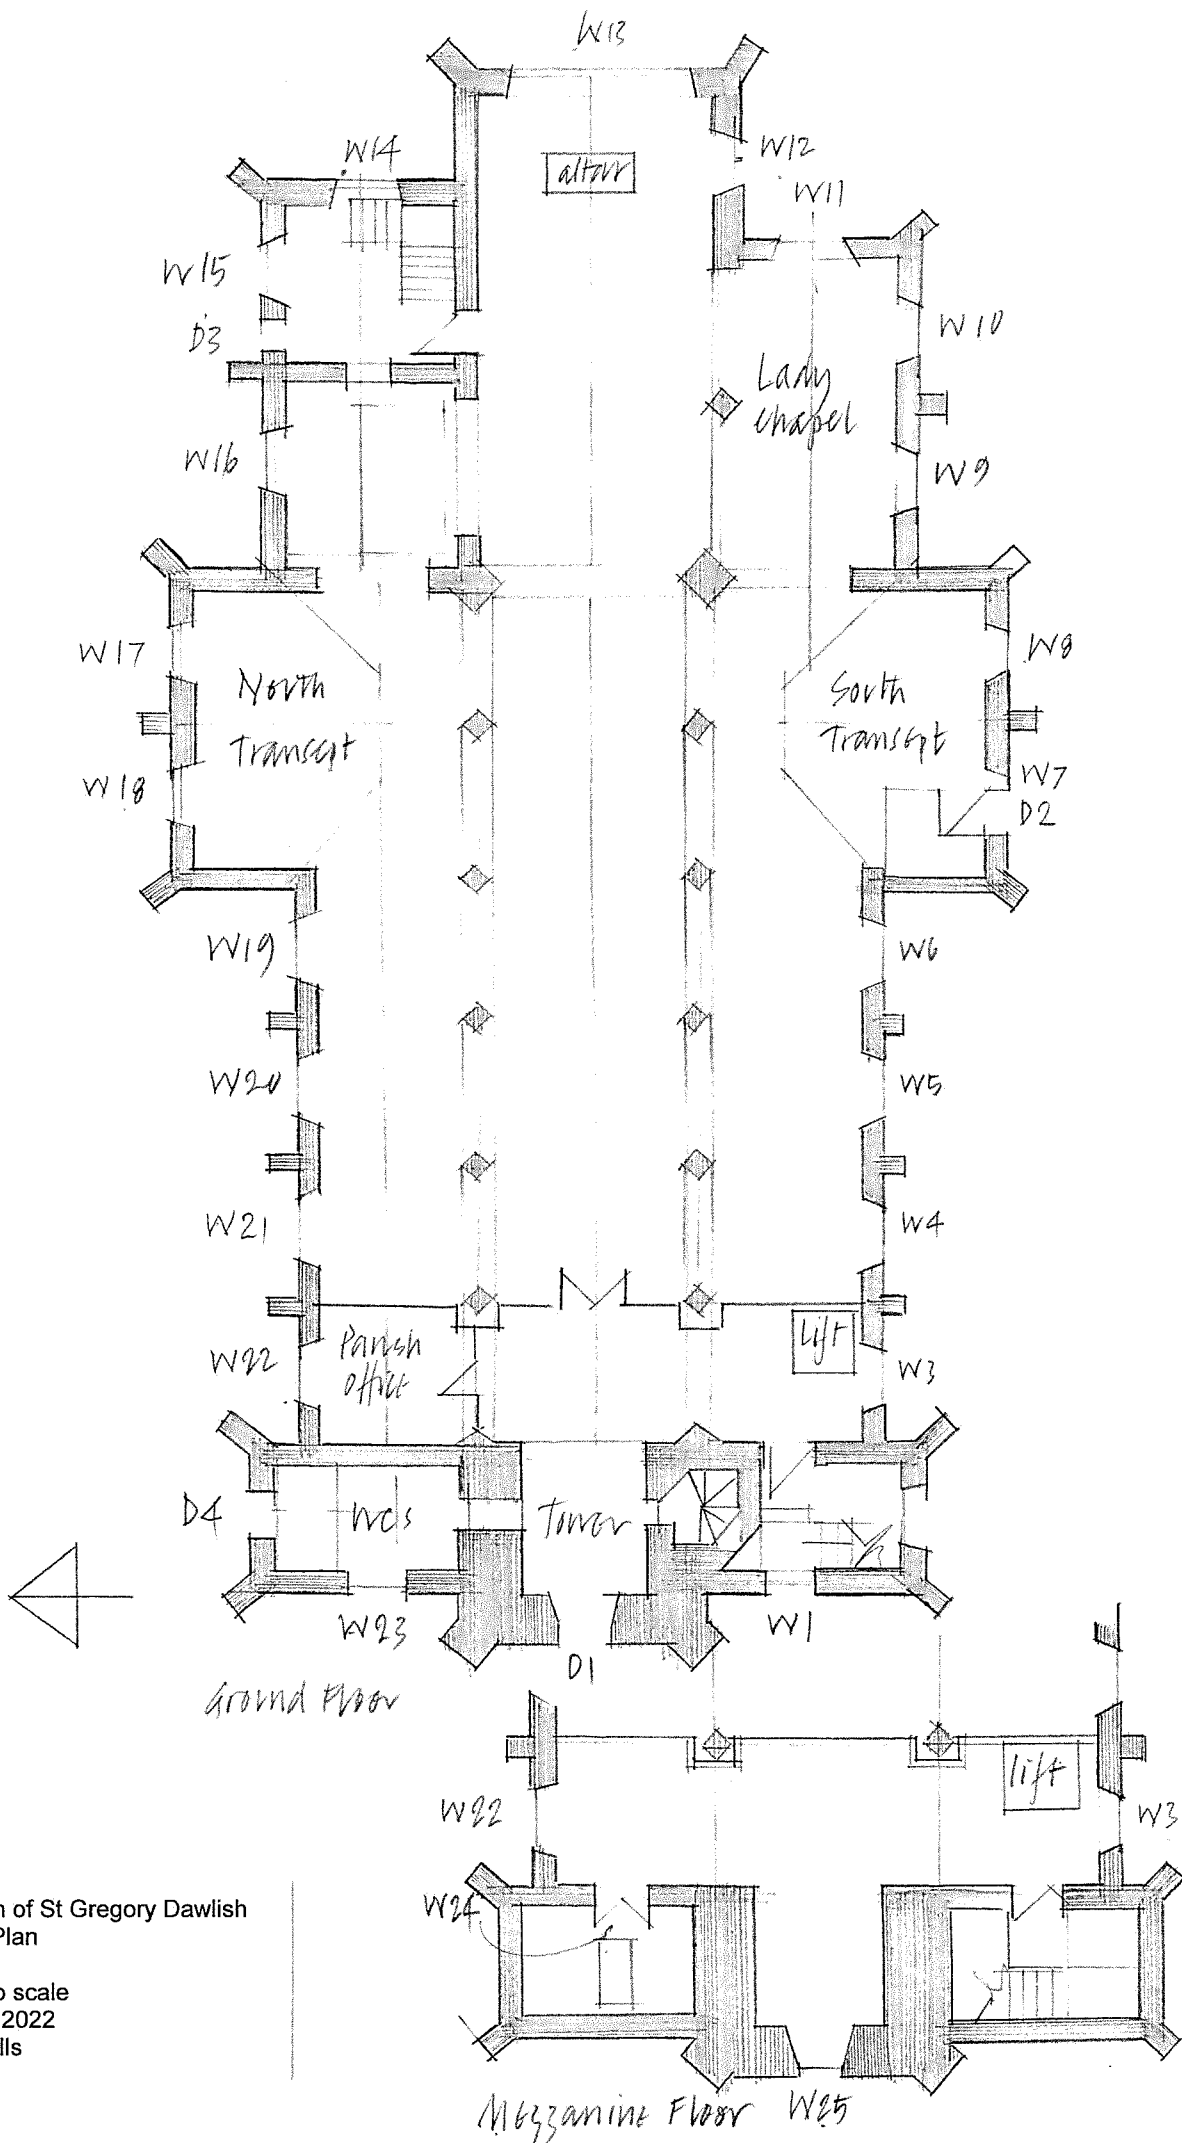
Appendix I – Church Plan

Church of St Gregory Dawlish
Floor Plan

Note to scale
March 2022
© Savills
